SERVICE ENGINEERING ALERT NOTICE

SEAN-007-2013

SUBJECT: Cracking Of Wing Lower Surface Skin At End Rivet Of Access Door Doubler AT WS 6.

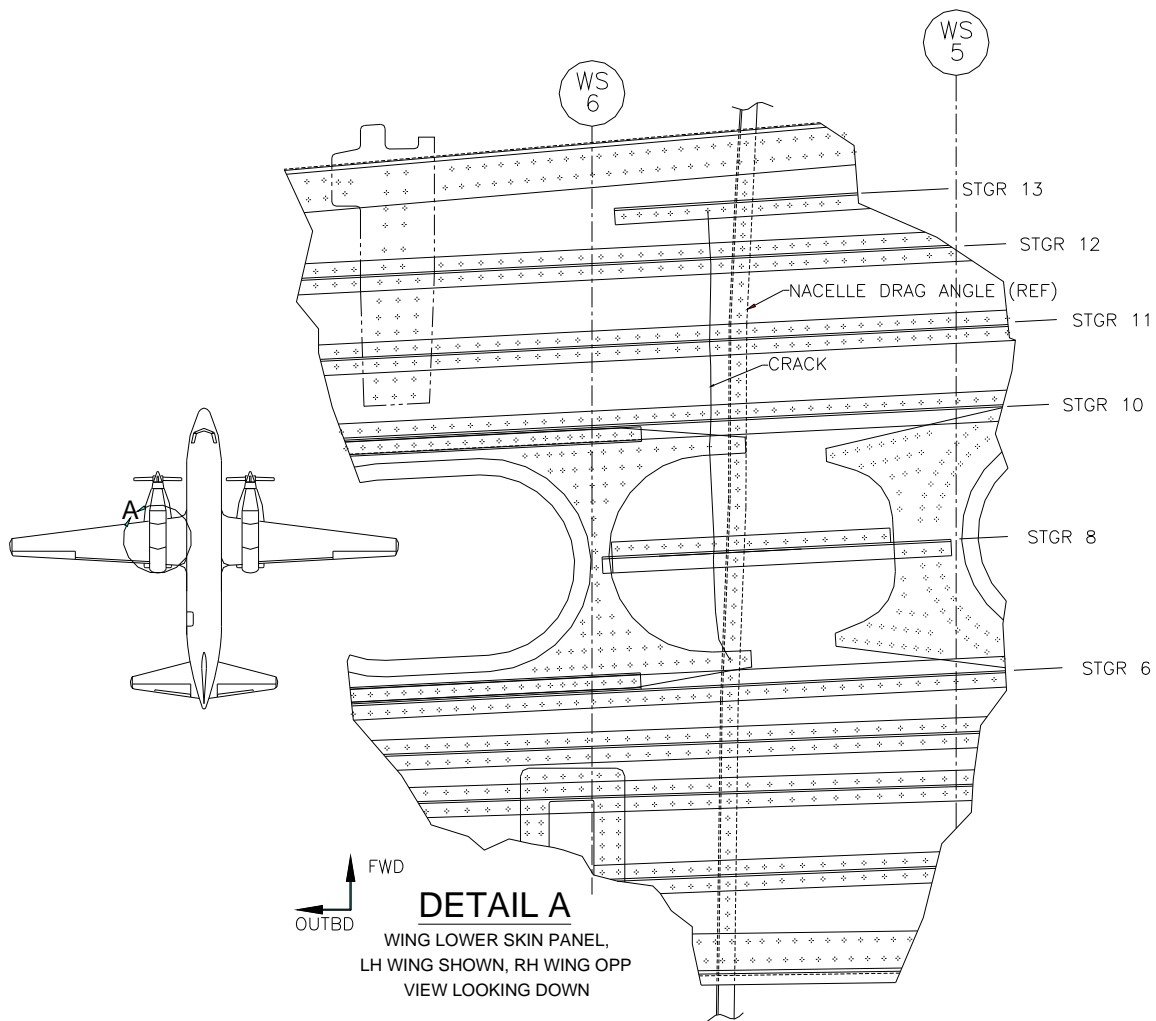
FIGURE 1 – Crack Location

An operator has reported finding a 28-inch long crack in the wing lower surface skin extending from a fastener location attaching the wing access door doubler aft finger to the lower surface skin, forward to a fastener location attaching Stringer 13 to the wing lower surface skin, as shown in Figure 1. The cracking was found during internal general inspection for corrosion.

An initial assessment has revealed that the external inspections specified by Ref [1] SSD 57-1-4 in the area of the access door doubler finger located between WS 5 and WS 6 are not effective.

The lower surface skin at the end rivets of the access door doublers is covered by the nacelle drag angle. In order to detect cracking of the wing lower surface skin in this area, internal inspections are required.

Kelowna Flightcraft Convaire Division considers cracking at this location as an airplane safety issue (potential of not being able to sustain limit load).

Pending release of the new Service Bulletin, Kelowna Flightcraft Convair Division recommends that operators accomplish a special inspection of the wing lower surface skin for cracks that may have gone undetected in the area of the access door doubler end fingers located between WS 5 and WS 6.
